# **Report on HS2 Ltd's Bowood Lane Mitigation site**

**29th August 2021**

This report is written by Mark Keir, of Jones' Hill Wood.

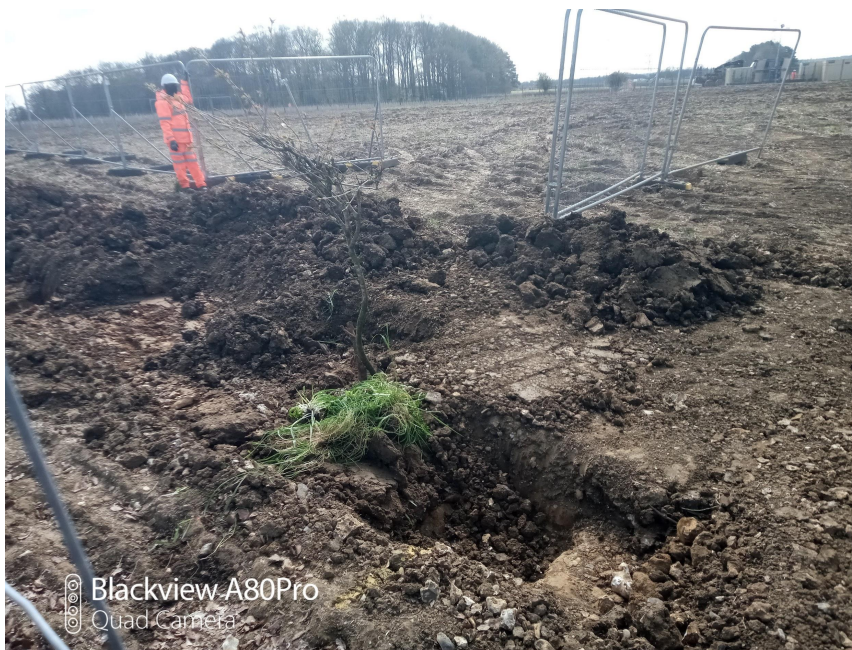
Fig 2

The receptor site host soil was compacted (Fig 2) pretty much daily with heavy machinery over the whole of winter '20/21 and was waterlogged much of that time. This was never ameliorated.

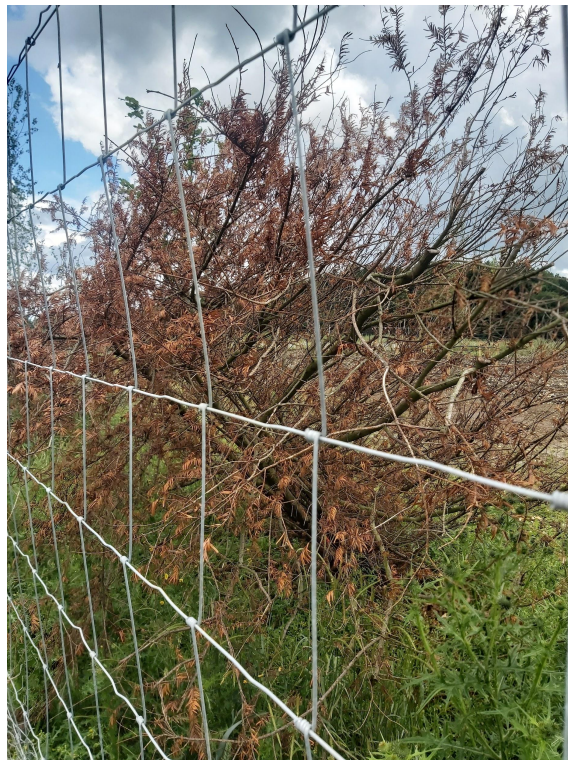
Fig 3

Of the translocated ancient hedge, it appears one plant is surviving, six barely surviving and unlikely to succeed. The other seventeen are quite dead including yews and hollies (Fig 3).

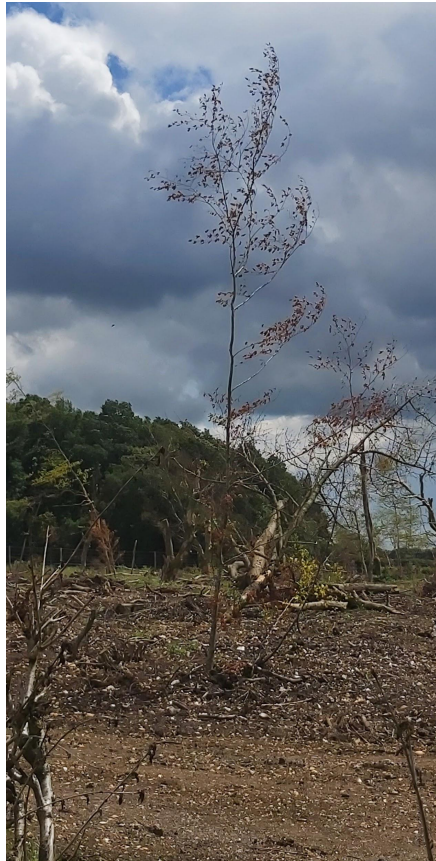
Fig 4

Few if any of the translocated trees taken for live specimens in the site have survived (Fig 4). In the receptor site there is a large empty space possibly equivalent to over a third the total area suggesting the area of mitigation falls well short of area of woodland destroyed (Fig 5). In addition to this the long new front to the ancient woodland, composed of newly exposed etiolated weak trees suggests that there will be much secondary damage unaccounted for in ecologists assessments.

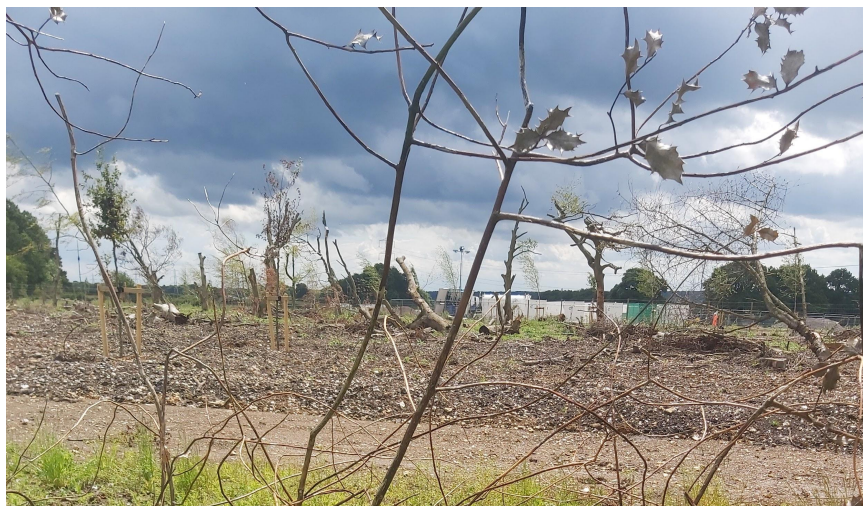
Fig 7

The supposed bat flightline trees within the receptor site are, as far as bats are likely concerned, lost amid a jumble of erratically placed considerably larger trees and monoliths (Fig 7).

There are two main lines of nursery grown semi-mature trees planted as flight corridors for bats, planted across the receptor site and the woodland planting site. Within the receptor site, as mentioned above, it is unlikely that these trees form any legible guide to bats (Fig 7).

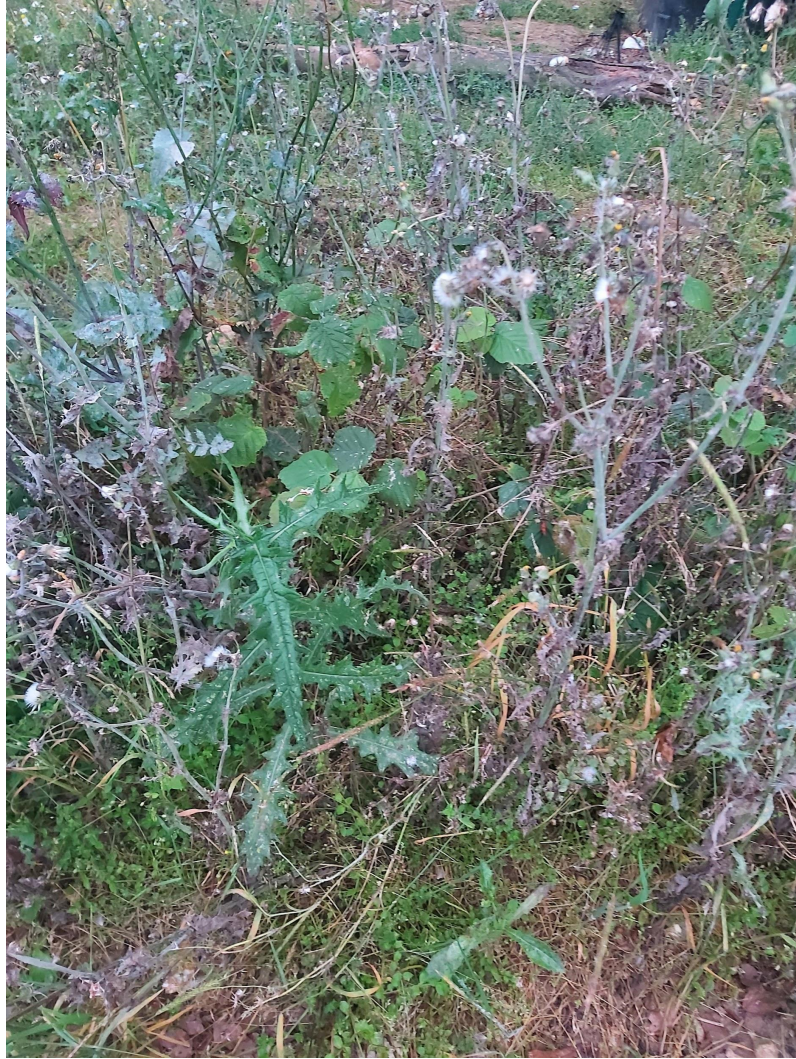
Fig 8

There are many smaller whips and pot grown plants added to the hedge and throughout the translocated site. These tend to be deep in weeds so only a rough estimate of around 25 - 30% attrition can be given (Fig 8)

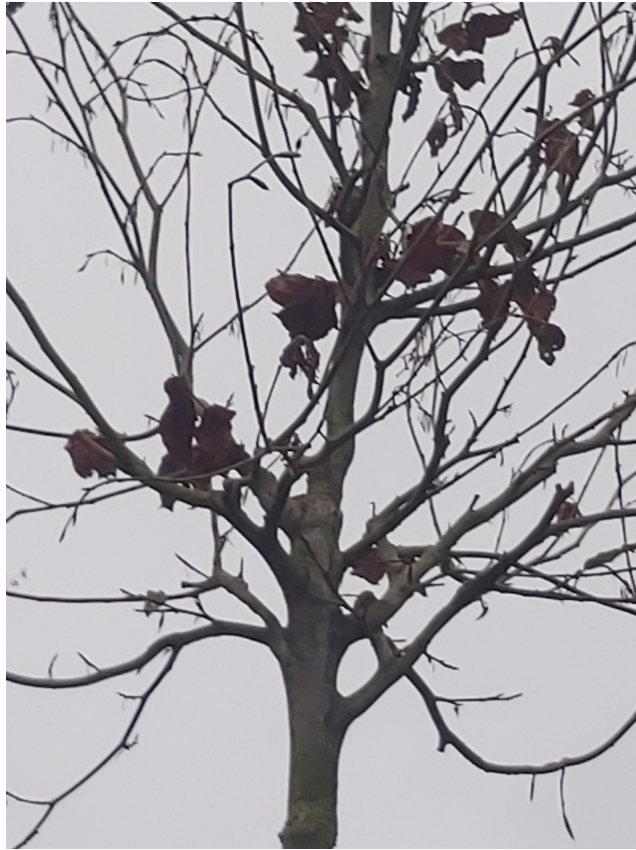
Fig 9

The majority of these trees appear heading toward untimely death. (Fig 9, Fig 10)

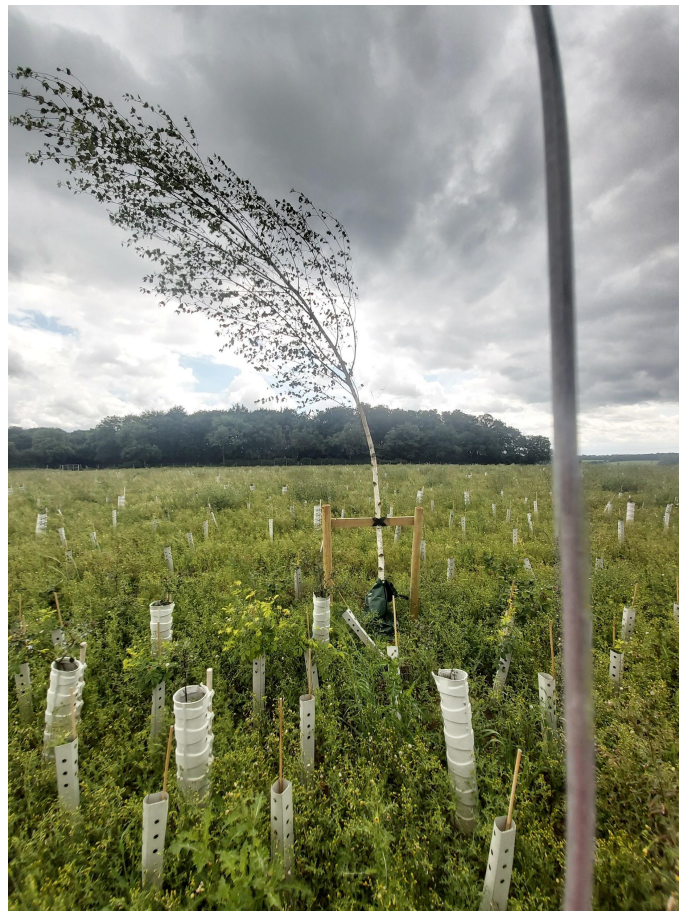
Fig 11

Along the contiguous northern perimeter of the receptor site and woodland planting site there are 37 of these trees, all with watering bags, but 24 are stressed to very stressed with a 10 probably dead. Many of these despite being given quite substantial supports (some months after planting) are leaning at precarious angles (Fig 11) and, furthermore, the ties to those supports are poorly executed (Fig 12) with only a small handful of trees actually benefitting from that support. Most will soon be seriously damaged by chafing at a critical height as wind rocks the trees on the hard supports. The water bags have only been seen being filled twice since planting in April.

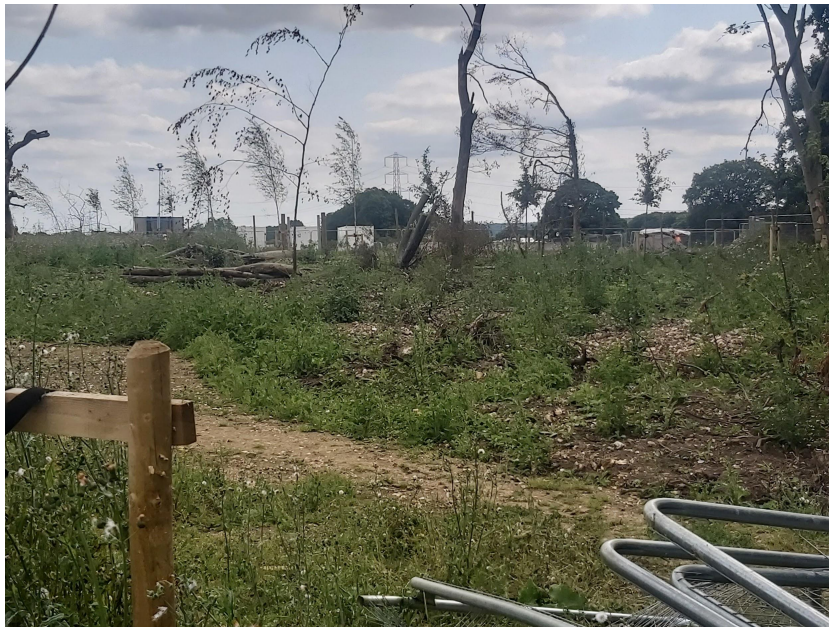
Fig 13

The second line of trees runs diagonally from Jones' Hill Wood to the unnamed wood at top of Bowood La. From a standpoint behind the northern fence, only 14 are assessable. 8 of those are clearly stressed, some possibly dead. 7 are close enough for the base of the tree to be discernable, and there are no water bags to be seen (Fig 13). Supports and tying follows the same pattern as above.

There appears to have been an application of herbicide along the north and east hedge boundaries (Fig 13), possibly to reduce wind blown seed contaminating adjacent agricultural land. If this is the case it looks to be a futile underperformance. There is a very considerable seed bank here which the local farmer must wince painfully when he sees.

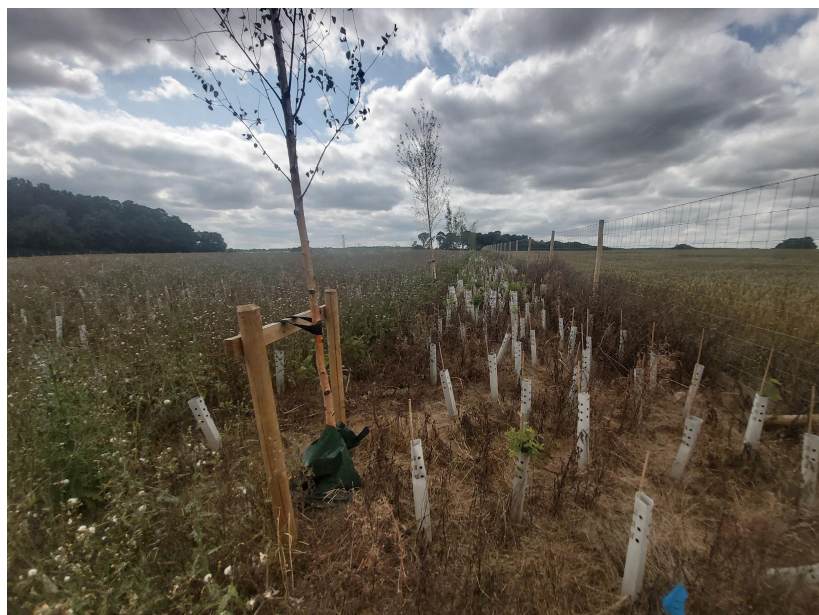
Fig 14

Plans I have seen show hedging along a serpentine edge to the fence line, but what has appeared is a straight line (Fig 14).

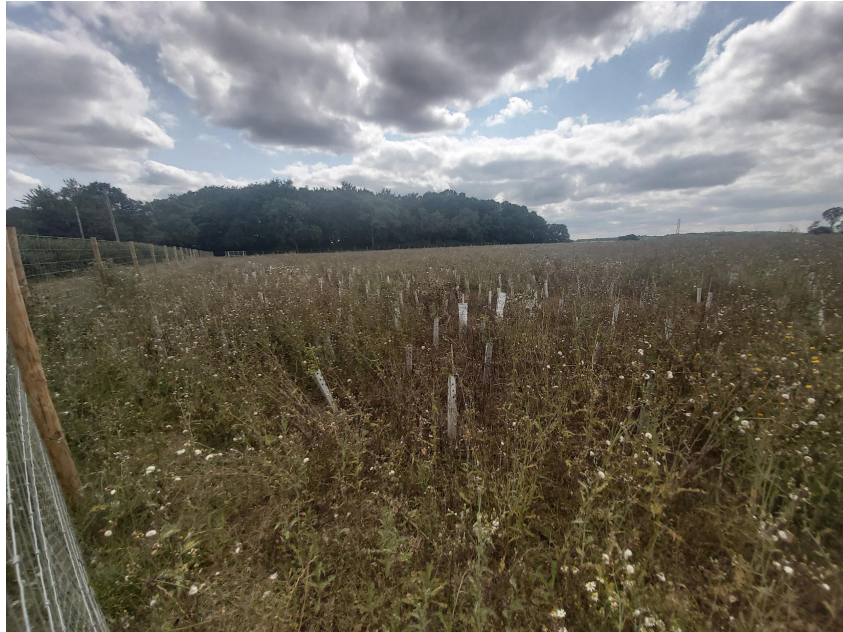
Fig 15

Most of the area is under a major infestation of weeds with the majority of whips quite invisible (Fig 15).

That same weed infestation and associated seed fall will have major implications for any seeding of open "glade" at centre of this area.

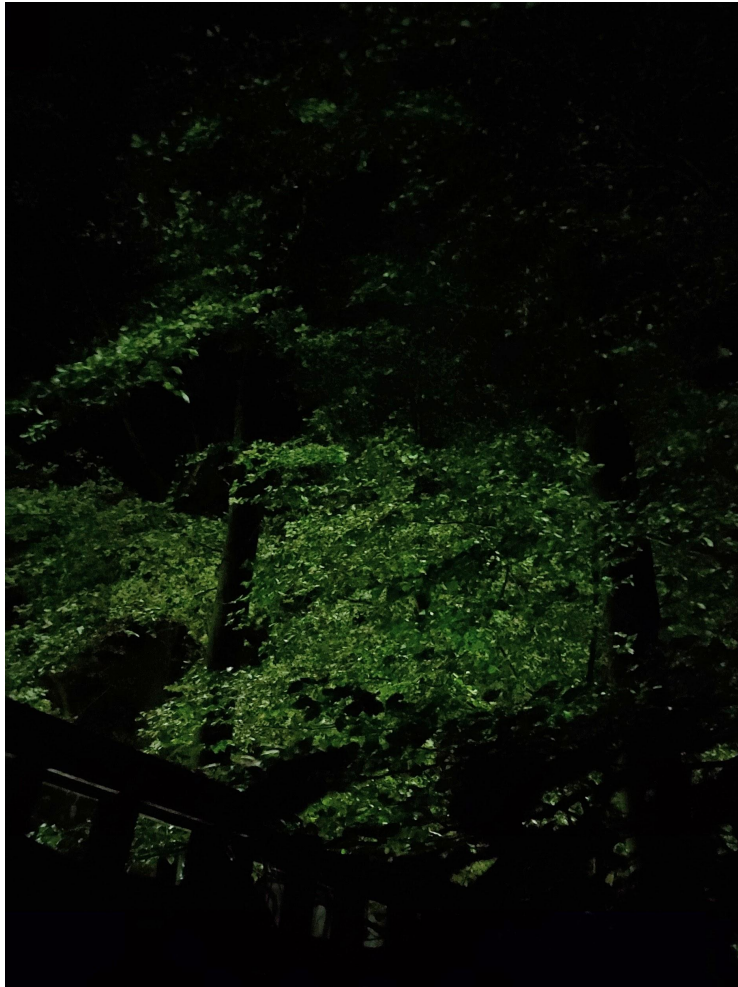
Fig16

Still this beleaguered strip that is now a wide open front to the Wood is floodlit every night (Fig 16), though lamp numbers have been reduced. The noisy generators now only run at night, coming on after sun down.

The flood lights still lie under some of the bat boxes sited here in April.

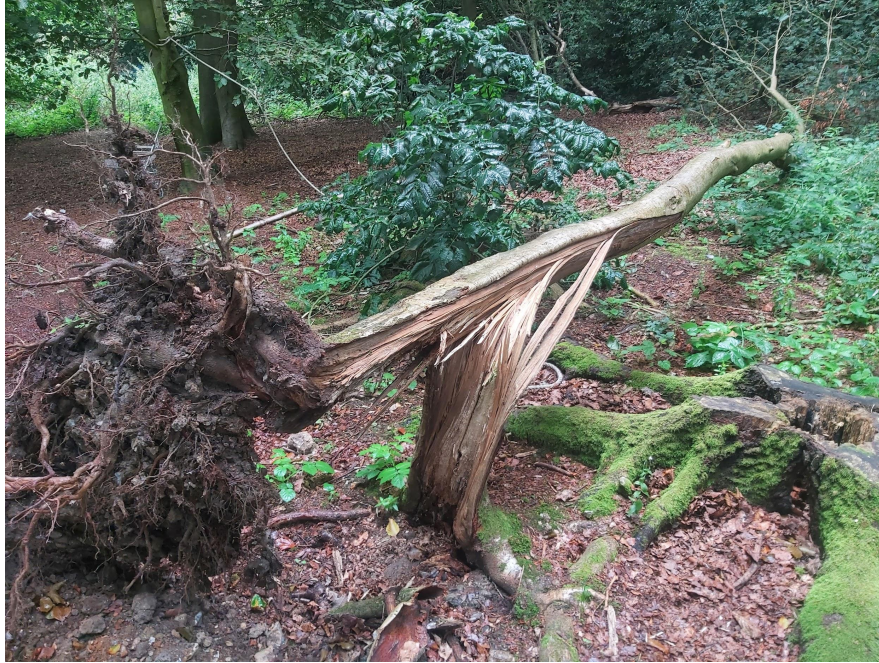
Fig 17

As mentioned above, the Wood now has a very wide open front allowing light and weather penetrate right through the heart of the Wood and already some weaker specimens on the supposedly safe side have sadly succumbed (Fig 17).
